# Removal and Replacement of Mercury Switch in 1980-1998 GM Rectangular Hood Lighting Assembly

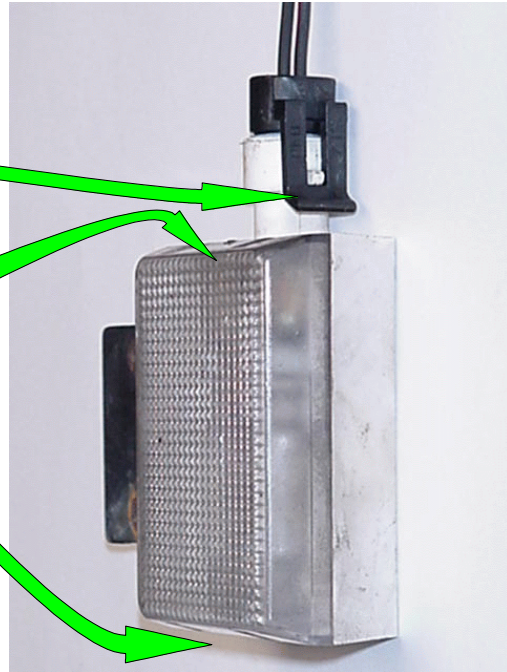
1. Remove the wiring clip by sliding a screwdriver under the clip and sliding the clip back to remove the power source

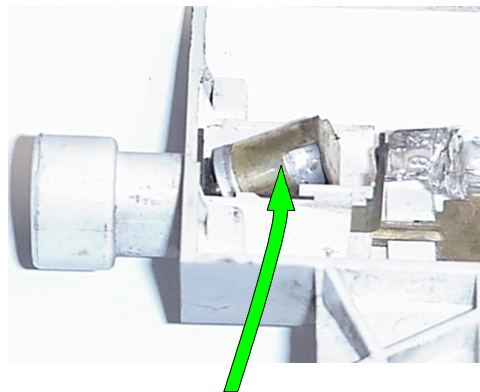
3. Pry up the mercury switch holder with a small screwdriver

4. Push the mercury switch out of the holder using a screwdriver and replace the mercury switch with a ball-bearing switch oriented as shown

5. Push the mercury switch holder back into place with a screwdriver and adjust the position of the switch to have the center conductor touch the copper strip on the assembly wall
